NORTHROP SCHOOL

E. 46th Street and 16 Avenue S.

1931

DETAILED REPORT

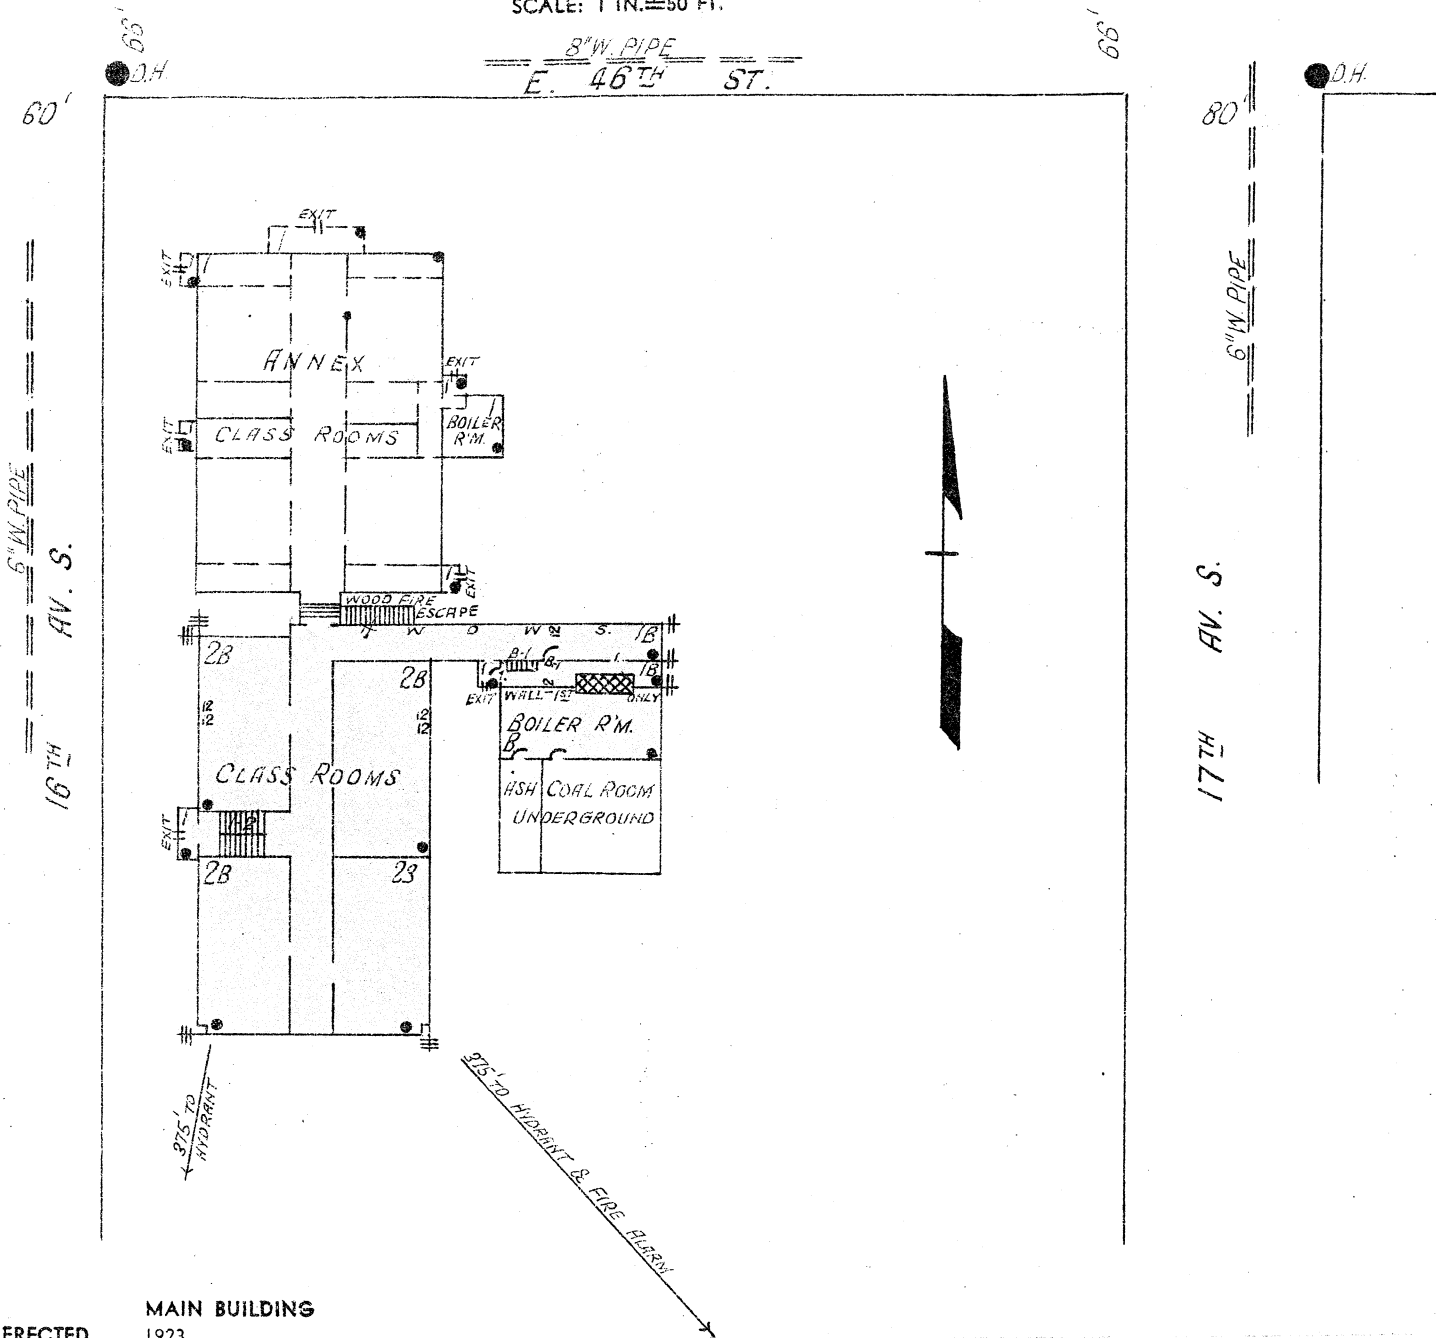
NORTHROP SCHOOL

The brick section is of fireproof construction, the annex frame and sections communicate with each other through one unprotected opening. Eventually the annex will be removed to make way for fireproof additions forming a typical grade school.
